# Bridge Inspection Program

## FY 98 Routine Inspections

September 1998

New England District

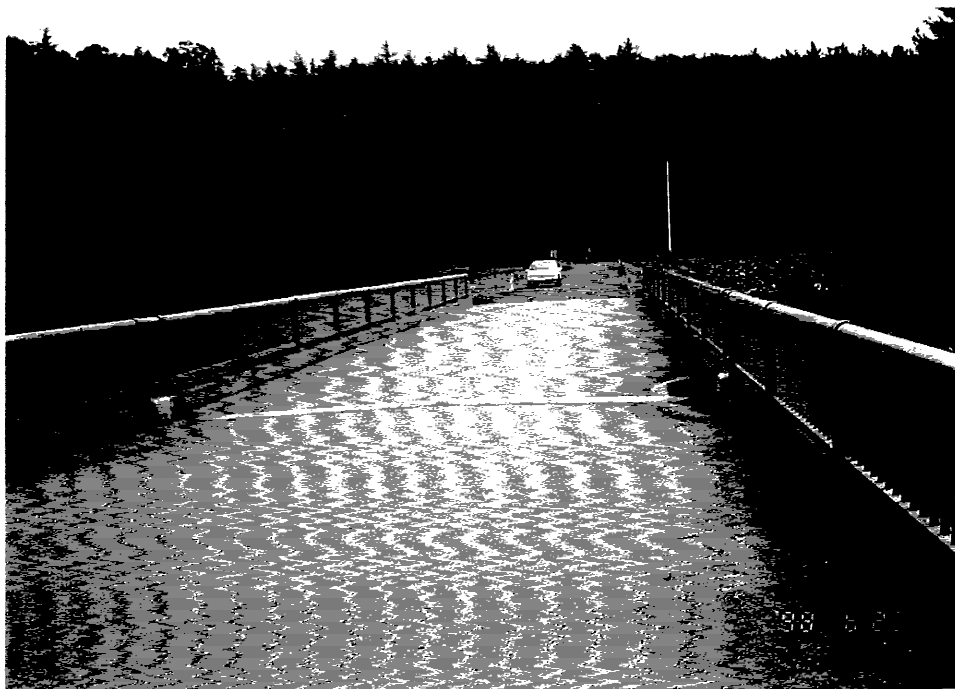
PHOTO 3. FREE STANDING WATER ON DECK
